Garratt's Damp & Timber Ltd.

SAMPLE SURVEY

The following survey was performed on a Victorian semi detached property in Notting Hill, London. The area of concern for customer was evidence of damp in a conservatory that had been added to the property just 8 years previously.

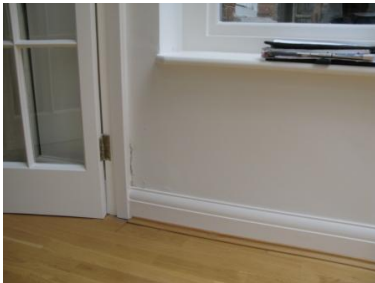
The only internal evidence of damp penetration was found where the conservatory was adjoined to rear wall or original building. The general condition of repair within dwelling was found to be very good and to a high standard.

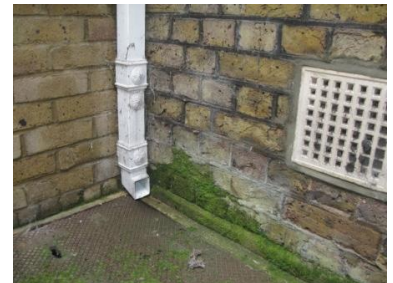
The side and rear walls of conservatory further evidence of damp and moss growth, an area of concern that would require treatment if the problems faced where to be checked. A high soil retaining wall (left of first picture below) was

noted, a source of possible problems. The pathway level allowed very little runaway, a classic construction should you want standing water to be present.

To test, water was flushed through the downpipe and it was noted that although no leaks were found, the water did not flow freely once on the path. Free flowing water would not have been adequately drained as the drain cover (foreground in final photo) was blocked.

- Injecting a chemical damp proof course to conservatory wall & adjoining rear wall of property
- Applying a waterproofing sealant to same
- Adding rendered plinth to same
- Clearing blockages to air bricks and drains

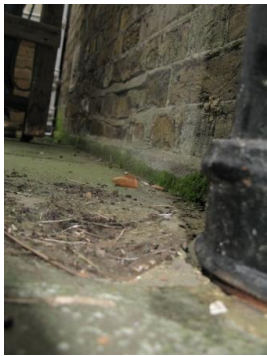
A guttering downpipe was present immediately behind damp on external wall, a prime candidate on face or it, but not necessarily the cause nor the only task for remedial work. The presence of moss below the damp proof level highlights existence of damp and possibly a history of retained water.

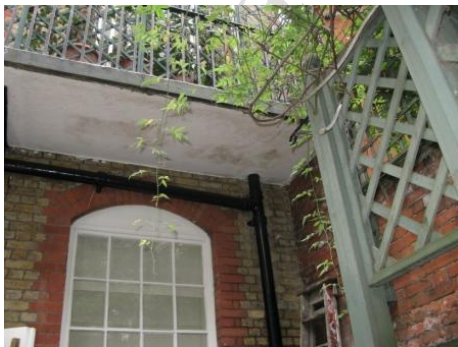
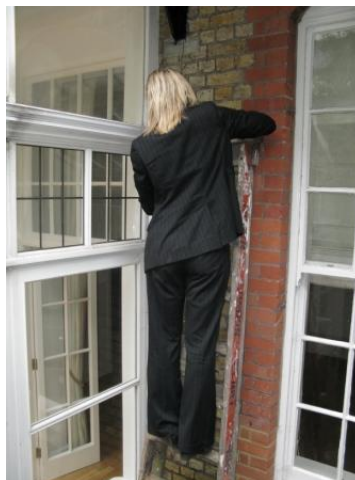
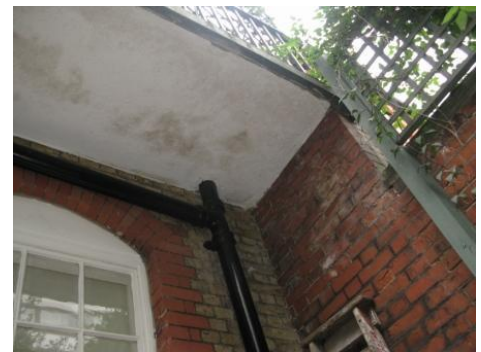
The surrounds to property showed other potential sources to the problem but following close inspection these were discounted, supported pictures are shown at the end of this document.
